LANDSLIDE INVENTORY MAP OF THE SUNCREST
DEVELOPMENT, DRAPER, UTAH

Prepared by:
Dr. James P. McCalpin
GEO-HAZ Consulting, Inc.
P.O. Box 837
Crestone, CO 81131

GEO-HAZ Project #2082
Date: Nov. 30, 2003

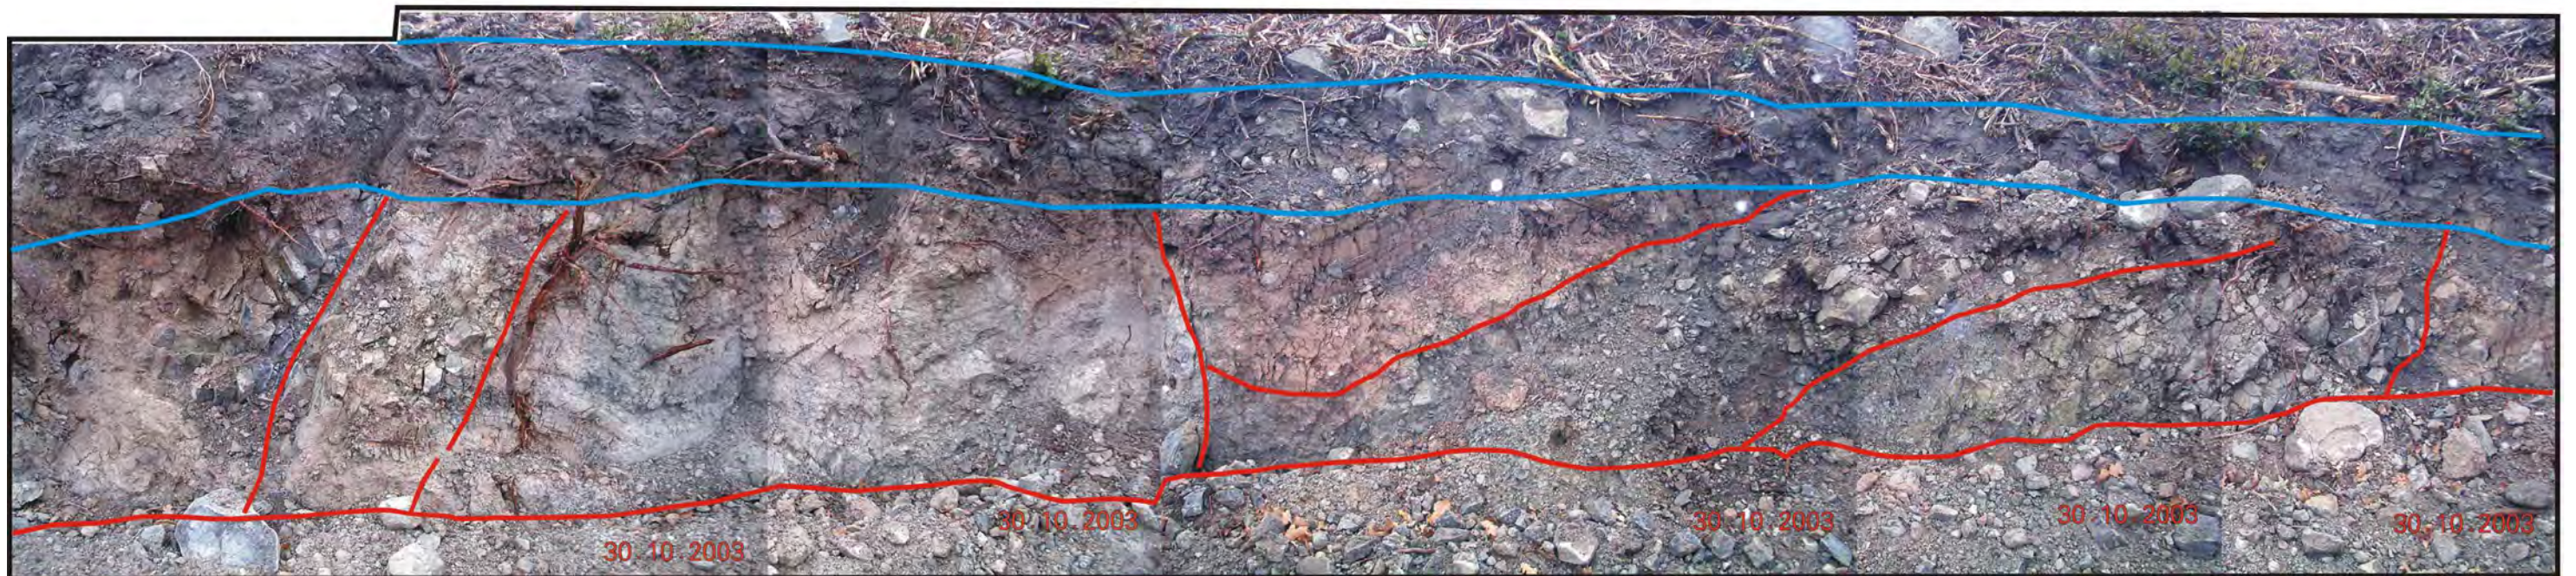
Fig. 4. Photo-mosaic of a south-facing roadcut on the southern margin of the 80-acre inholding in central Suncrest. Lower panel, annotated photomosaic; upper panel, interpretation.

Roadcuts along the southern margin of the 80-acre inholding (rectangle in southern lobe of Polygon #18) show the complex and heterogenous nature of the volcanic rock (Fig. 4). Several volcanic and volcanoclastic rock types are juxtaposed along subvertical contacts, some of which appear to be shear zones.
