# Sackungen at the Aspen Highlands Ski Area, Pitkin County, Colorado

JAMES P. McCALPIN

*GEO-HAZ Consulting, Inc., P. O. Box 1377, Estes Park, CO 80517*

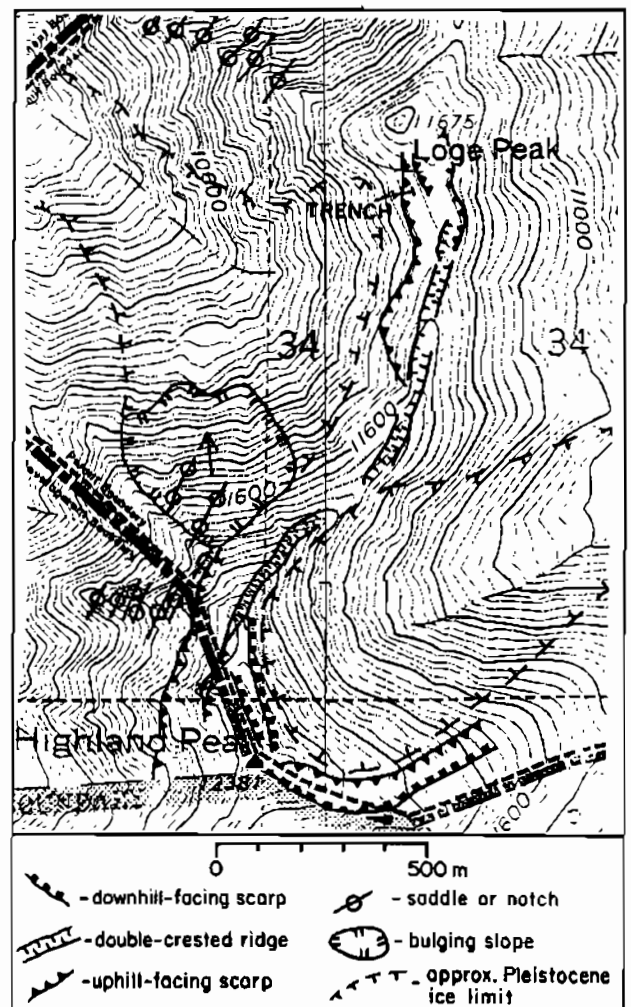
Figure 3. Geomorphic map of sackungen in the AHSA. Contour interval is 12.2 m (40 ft). Cirques are outlined by the approximate Pleistocene ice limits (trimlines). The Highland Bowl is at lower right, Maroon Bowl is at upper left. Arrow indicates possible movement direction of bulging slope at the head of the Maroon Bowl.

Sackungen are found dominantly along ridge crests and at the top of steep cirque headwalls (Figure 3). With the exception of the curvilinear scarps around the rim of the Highland Bowl (Figure 3), most sackungen are linear, 200–500 m long, and trend between N25°–45°E, parallel to the major joint set (strike N25°–45°E, dip 80°–90° NW) in the Maroon Formation (Figure 4). The geomorphic

Downhill-facing scarps are best expressed around the rim of the Highland Bowl (Figures 3 and 4) and form a semicircle around the cirque headwall. At the head of the cirque the scarps are 3–8 m high and are separated by surfaces that slope toward the scarp and create topographic depressions at the foot of the scarps. At the ends of the semicircular pattern this back-tilted block geometry gradually changes to one of asymmetrical

The site for detailed study is a gently-sloping meadow located approximately 200 m south of Loge Peak (Figure 3). We chose this uphill-facing scarp and its associated trough for excavation because the closed depression had a lush grass cover that suggested the presence of thick, fine-grained trough sediments, possibly containing interbedded buried organic soil horizons. The trench was aligned perpendicular to the strike of the sackung scarp and trough, with the downslope end of the trench placed in a shallow circular depression on the

Sackungen at the AHSA are found only where the maximum mass has been removed from the ridge flanks by headward erosion of the Highland and Maroon cirques (Figure 3). Almost all sackungen are linear and parallel to the dominant N25°–45°E joint set in the Maroon sandstone. Artificial cuts for ski facilities have shown that joints of this orientation at the ridge crest stand open 3–5 cm at depths of up to 15 m below the

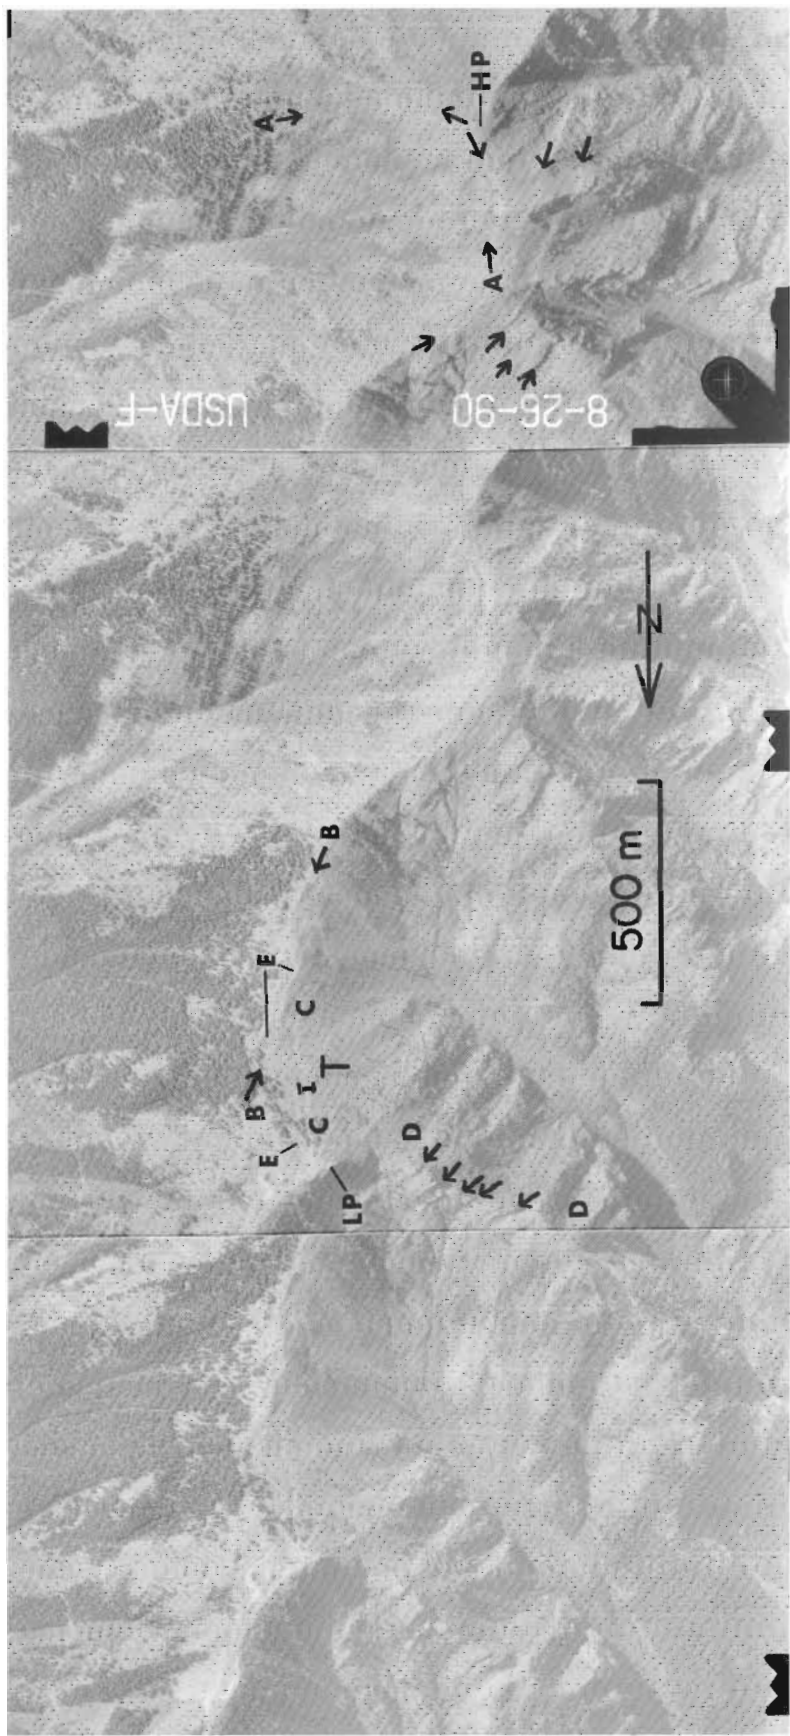
Figure 4. Stereo aerial photographs of sackungen at the AHSA. Arrows show scarps, troughs, and notches. The areas between arrows labelled "A" through "D" show locations of ground photographs in Figure 5A through D, respectively. "E"'s indicate closed depressions. The short heavy line marked by "T" indicates the location of the backhoe trench. LP = Loge Peak, HP = Highland Peak.

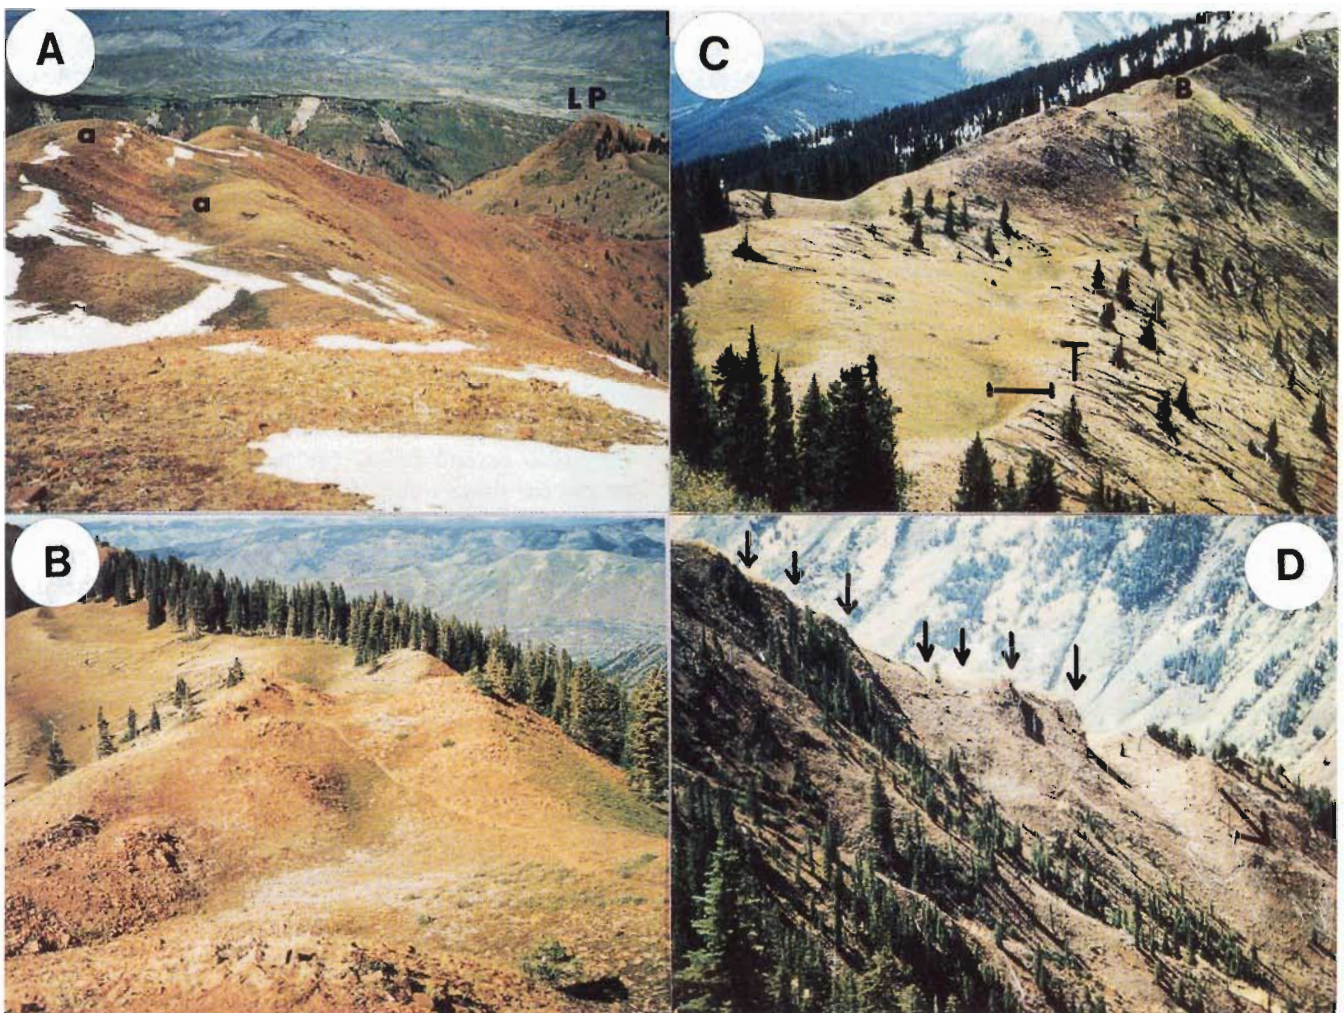
Figure 5. Ground photographs of sackung features: A) Downhill-facing scarps immediately NNW of Highland Peak. Photo was taken from the summit of Highland Peak looking NW; vertical distance between “a”s is 8 m. LP = Loge Peak, valley of the Roaring Fork River in distance. B) Double-crested ridge between Highland Peak and Loge Peak (just off photo at upper left corner), looking NNE. Vertical distance from the bottom of the axial trough to the top of flanking ridges is 2–3 m. Footpath in the center is 0.5 m wide. Photograph was taken from the location marked “B”. C) Uphill-facing scarps are in the meadow south of Loge Peak, view to SE. The trench site is shown by a horizontal bar with “T”. D) Saddles and notches (small arrows) are on the axis of a steep ridge descending to Maroon Creek (valley in background), looking SW. Note the wedge failure (large arrow at far right) defined by sackung notch (farthest right vertical arrow).

#### Downhill-Facing Scarps Along Cirque Headwalls (Figure 5A)

Double-Crested Ridges (Figure 5B)

Double-crested ridges (the "Doppelgrate" of Zischinsky, 1969) are a classic sackung landform. The axial depression typical of Doppelgrate is difficult to explain by an erosional process, because streams are unlikely to flow down the crest of a ridge and the closed depressions could not have been excavated by running water. The long ridge between Loge Peak and Highland Peak (Figure 3) displays a double crest with intervening swales or closed depressions over much of its 1-km length. Ridges such as these are inferred to have undergone lateral spreading (Zischinsky, 1969; Varnes et al., 1989), with the central depressions representing either graben (Figure 6A) or headscarps of downslope movements (Figure 6B) similar to that shown in Figure 5A.

Uphill-Facing Scarps (Figure 5C)

Saddles, Notches, and Wedge Failures on Ridge Axes (Figure 5D)

On the western flank of Highland Peak several steep ridges descend more than 1,000 m to the valley floor on either side of a cirque informally named the Maroon Bowl. These ridges are split by numerous saddles and notches along the steep ridge crest. The notches are only visible on the treeless parts of the ridge above the Pleistocene glacial trimline of the Maroon Creek valley, but may also extend below the treeline. While a sackung origin for these notches cannot be proven, their parallelism with other unambiguous sackungen, and their sudden appearance above the glacial trimline are consistent with a spreading origin related to deglacial unloading. Several bedrock wedge failures occur on the steep ridges, apparently failing down the line of intersection between bedding planes dipping at 25°–45° and dilated sackung (?) joints dipping 80°–90° (Figure 5D, lower right).

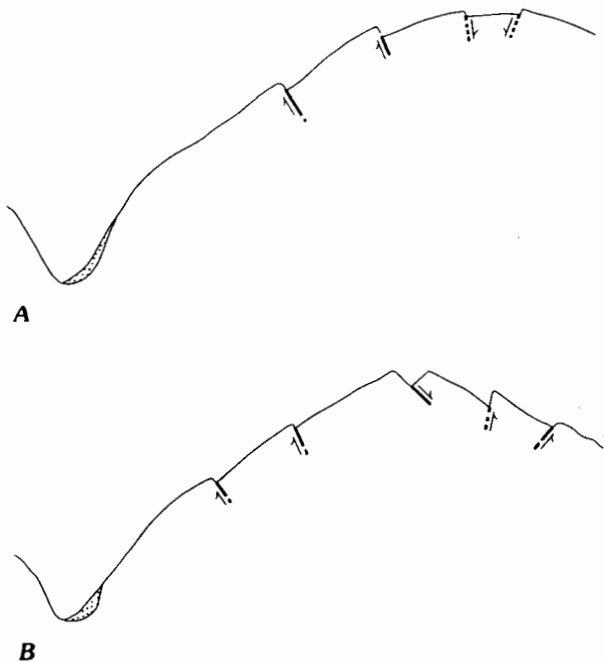
Figure 6. Sketch of typical profiles across spreading ridges in massive crystalline rocks. A) Summit graben and uphill-facing scarps; B) Double-crested ridge and uphill-facing scarps (from Varnes et al., 1989, Figure 3).

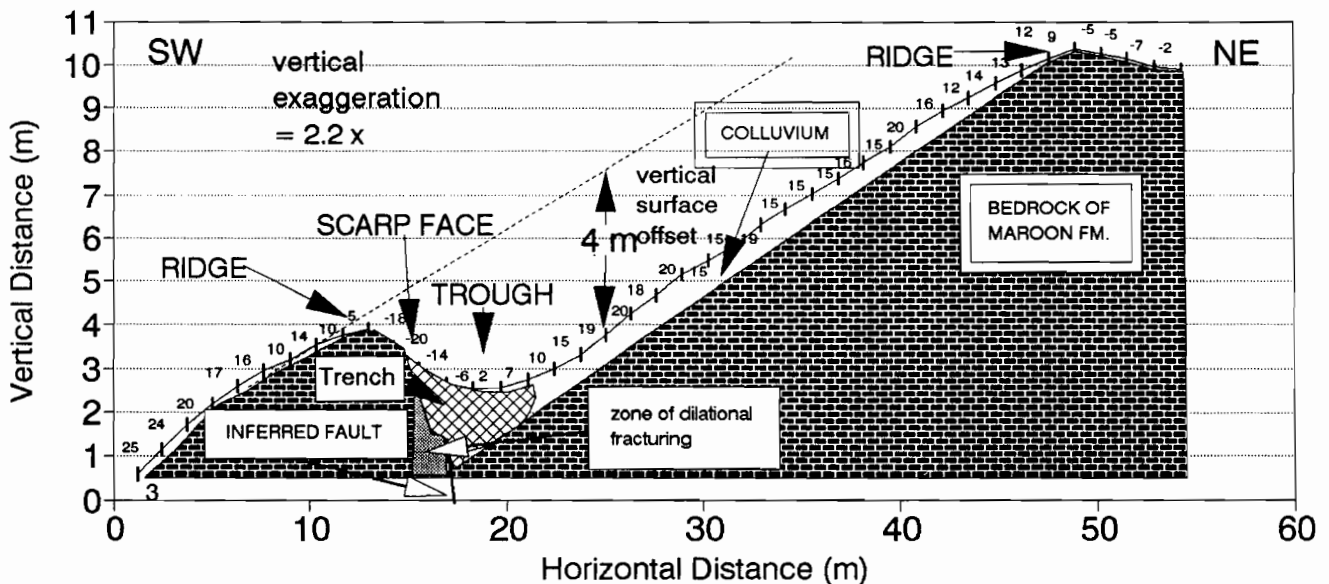
Figure 7. Generalized geologic cross-section across the uphill-facing scarp at the trench site. Small numbers above the ground surface show inclination of surface slope segments in degrees. The backhoe trench is shown by crosshatched area. The thickness of colluvium (unshaded) is inferred except at the crest of scarps and in the trench.

A minimum estimate of the cumulative vertical displacement (throw) of trough fill could be made if the initial dip and westward extent of unit 6A were known. The most conservative assumption is that such a richly organic A horizon was originally horizontal on the trough floor, and that it extended at least as far west as its preserved extent. An alternative assumption is that the western part of this soil (as well as that of soils 5A and 4A) was eroded off the upthrown block after uplift. Under this assumption, throw can be estimated by presuming that soil 6A originally extended as far west as soils 2, 3, and 4 (0.9 m farther SW than present), and was later tilted from a 0° dip to its present maximum dip of 75±5°. By trigonometry, the throw associated with 75±5° of tilting over a horizontal distance of 0.9 m equals 2.5–5.1 m, which is in the same range as the 4 m of vertical surface offset between bedrock at the trench floor and the projected bedrock surface shown in Figure 7. This computed

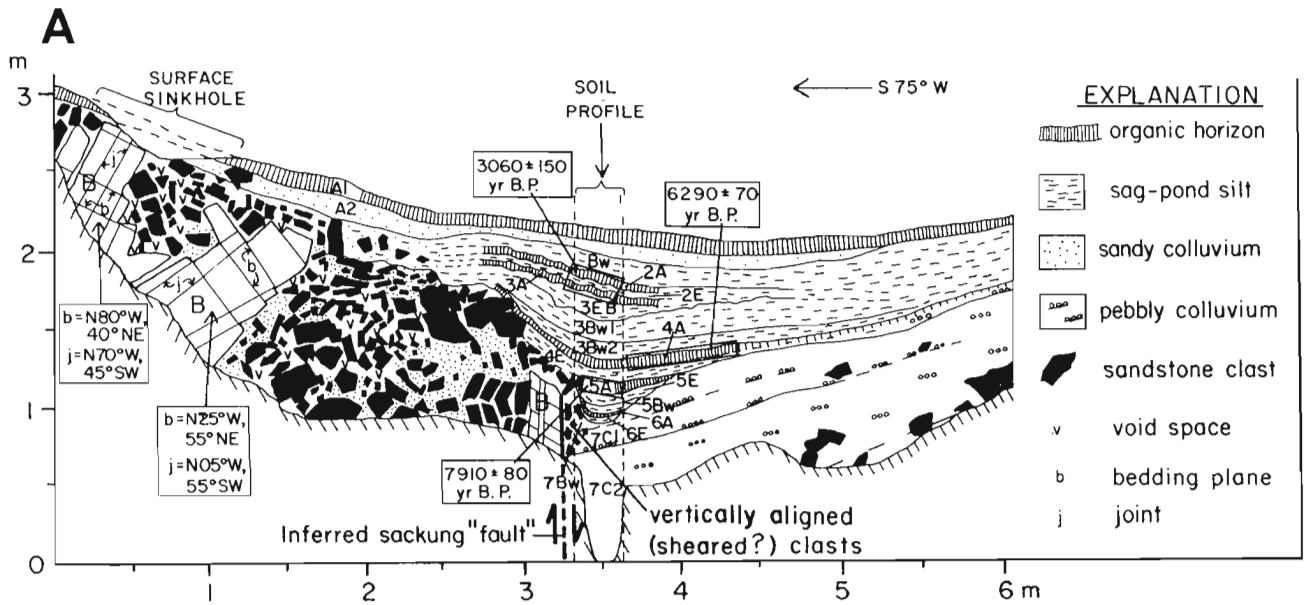
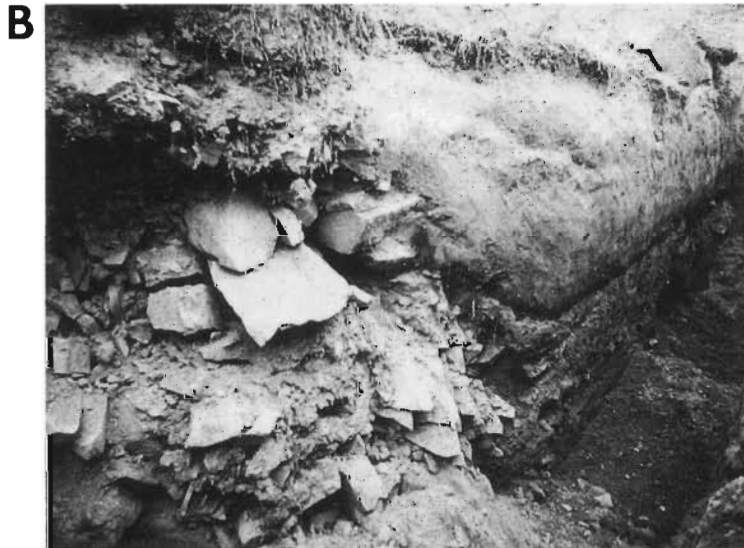
Figure 8. A) Log of the trench across the sacking scarp and trough. In intact bedrock masses (“B”) b = attitude of bedding, j = attitude of joints. Radiocarbon ages (in boxes) are in radiocarbon years before present; see Table 2 for calendar-corrected ages. Stratigraphic units 1–8 described in the text are indicated by parent material numbers in the soil profile; B) Photograph of trench wall. Intact rock at lower center is marked by a “B” on the trench log, and immediately abuts the sacking fault plane. Note open void spaces at left center and lower left. Soil horizon 4A is the prominent black band at right center, which is bent upward as it approaches the sacking fault plane.

The trench exposes eight lithologic units under the scarp face and trough (Figure 8). The first unit is sandstone bedrock of the Maroon Formation (B in Figure 8A) that underlies the scarp face and contains pockets of coarse, angular rock rubble. Bedding in the fine-grained micaceous sandstone is well-defined, with beds 15–30 cm thick, and attitudes of N80°W, 40°NE to N25°W, 55°NE. The trough is underlain by seven unconsolidated deposits. The lower deposit (unit 7, Figure 8A) is a reddish gravelly sand that contains an increasing number of angular sandstone clasts near the bottom of the trench. Based on the presence of these clasts and the difficulty of excavation below them, we infer that intact bedrock lies immediately under the trench floor. The gravelly sand appears to be locally derived from weathering of Maroon Formation sandstone and contains occasional well-sorted lenses of subangular granule gravel suggestive of sheetflow deposition or dry ravel. We thus infer that unit 7 represents hillslope colluvium derived from weathering of exposed sandstone bedrock. The colluvium abruptly terminates in a vertical contact with shattered bedrock in the center of the trench.

The upper unconsolidated deposits (units 1–6, Figure 8A) comprise a series of fine-grained trough fill sediments and interbedded soil horizons. These sediments do not resemble the underlying colluvium in either color or texture, being buff to brown rather than red and composed mainly of silt with little sand and no clasts. Based on the fine grain size, anomalous color, and rich organic nature of interbedded soils, we infer that these sediments

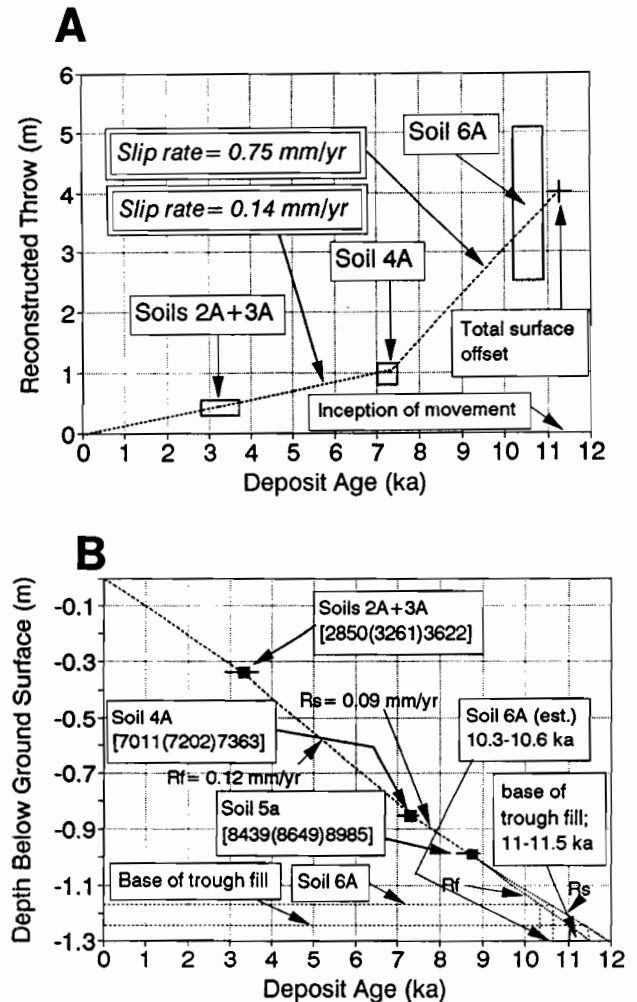
Figure 9. A) Reconstructed throw for three soils and total surface offset, as a function of deposit age. Horizontal dimension of boxes is defined by 1-sigma limits of calendar-corrected ages (Table 2). The age for soil 6A is derived from extrapolation in Figure 9B. Vertical dimensions of boxes represent the range of throws resulting from uncertainty in maximum dip angle for each soil used in the trigonometric calculations (see text). The dotted line shows apparent vertical slip rates on the sackung fault. B) Deposit age (Table 2) as a function of depth below the ground surface in the trough fill. The dotted line shows apparent deposition rates: Rf = fast deposition rate, Rs = slow deposition rate. Depending on which deposition rate is extrapolated to the bottom of the trough fill, the inception of sackung movement ranges from 11–11.5 ka.

The age of soils as a function of depth below the ground surface (Figure 9) indicates fairly uniform silt deposition rates between periods of soil formation. Rates range from a slow rate (Rs on Figure 9B) of 0.09 mm/yr between 7,202–8,649 cal yr B.P., to an intermediate rate of 0.11 mm/yr between 3,261 cal yr B.P. and the present, and to a rapid rate (Rs in Figure 9B) of 0.12 mm/yr between 3,261–7,202 cal yr B.P. The fast and slow rates, when projected downward, yield estimated ages of 10.3–10.6 ka for soil 6A, the oldest soil developed in the trough fill, and an age of 11–11.5 ka for the base of the trough fill (unit 6Bw/7 contact). This latter age is the closest approximation to the time of formation of the sackung scarp and trough.

Data in Figure 9 show the sackung was originally produced about 11–11.5 ka. Numerous radiocarbon ages indicate that deglaciation of mountain valleys in Colorado following the last glacial maximum (20–22 ka) had been fully completed by 14–15 ka (e.g., Porter et al., 1983). If the buttressing effect of valley ice was removed no later than 14–15 ka, why did the sackung not begin to form until 11–11.5 ka? One answer is that the strain recovery took 2.5–4.0 ka to propagate from the glacial trimline at an elevation of 3,110 m to the trench site over 1,000 m farther up the ridge flank at an elevation 3,490 m. Bovis (1982, his Figure 11) constructed a series of diagrams showing how retrogressive movement may have occurred in British Columbia, but the diagrams do not have spatial or temporal scales. McCleary and others

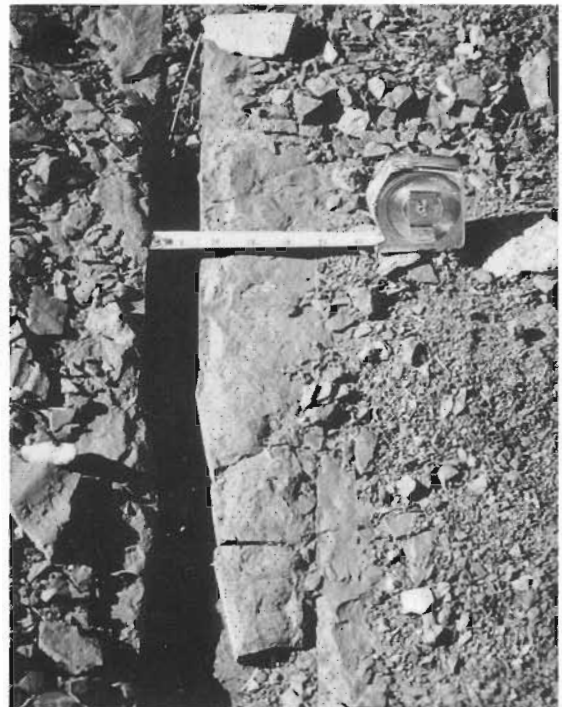
Figure 10. Photograph of open (dilated) joint on the floor of a 15-m deep cut into the State Bridge Formation (Permian–Triassic), approximately 400 m north of Loge Peak. Numbers on tape measure are inches. End of tape could be lowered 1.5 m into this joint.

original ground surface (Figure 10). The implication of these observations is that sackungen are caused by near-surface lateral spreading perpendicular to the ridge crest. It is not possible to state whether the failure mode is deep-seated sliding or shallow flexural topping, because no toe bulges are observed. Tracing the fracture zones downward via geophysical techniques was considered impractical due to the homogenous nature of the Maroon Formation and the minor displacement across the sackung fault.
